RIFF JTAG Error codes and troubleshooting Error: Wrong DCC Data Checksum 2. Wrong DCC Data Checksum

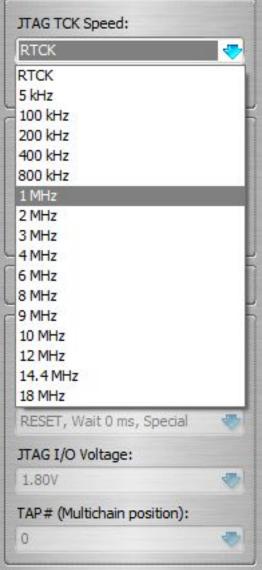
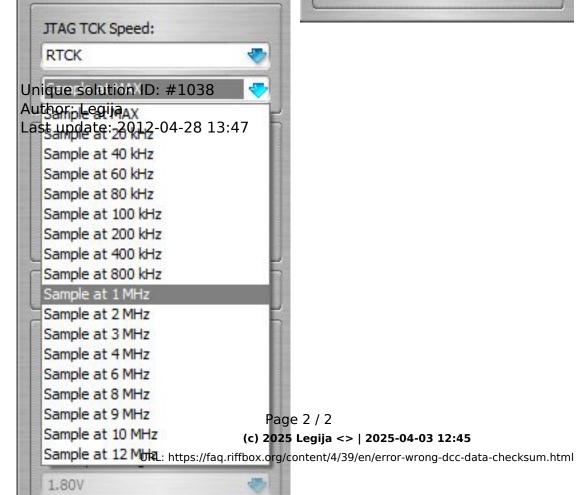
RTCK Settings and TCK settings:

Happens when DCC Loader which is being executed by target is too slow to respond through the DCC channel. Since RIFF BOX's firmware in normal state never checks DCC channel RX and TX ready flags (such checks slow down the communication speed and were decided to be omitted) sometimes it happen DCC Loader supplies data to DCC channel slower than BOX's firmware reads from it. Thus trash is received.

User shall lower TCK/RTCK Sampling speed settings in order to allow more slow communication between DCC Loader and host.
