RIFF JTAG Error codes and troubleshooting Failed to receive answer to READ command.

RIFF JTAG Error codes and troubleshooting

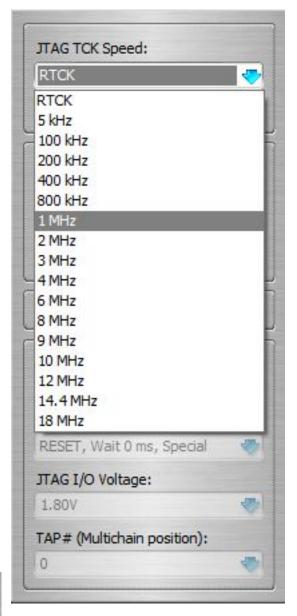
Failed to receive answer to READ command.

This error happens mostly due to high RTCK/TCK sampling rate. If You're using "Sample at Max" RTCK settings, set RTCK to lower value, for example to 1MHz. If You're using Fixed TCK, set it to lower value.

This problem can be also caused by bad connection, or bad 20pin ribbon cable. In some cases with the discussion of the cases of the cas
