RIFF JTAG Error codes and troubleshooting

Error code 0x39 (0x3901)

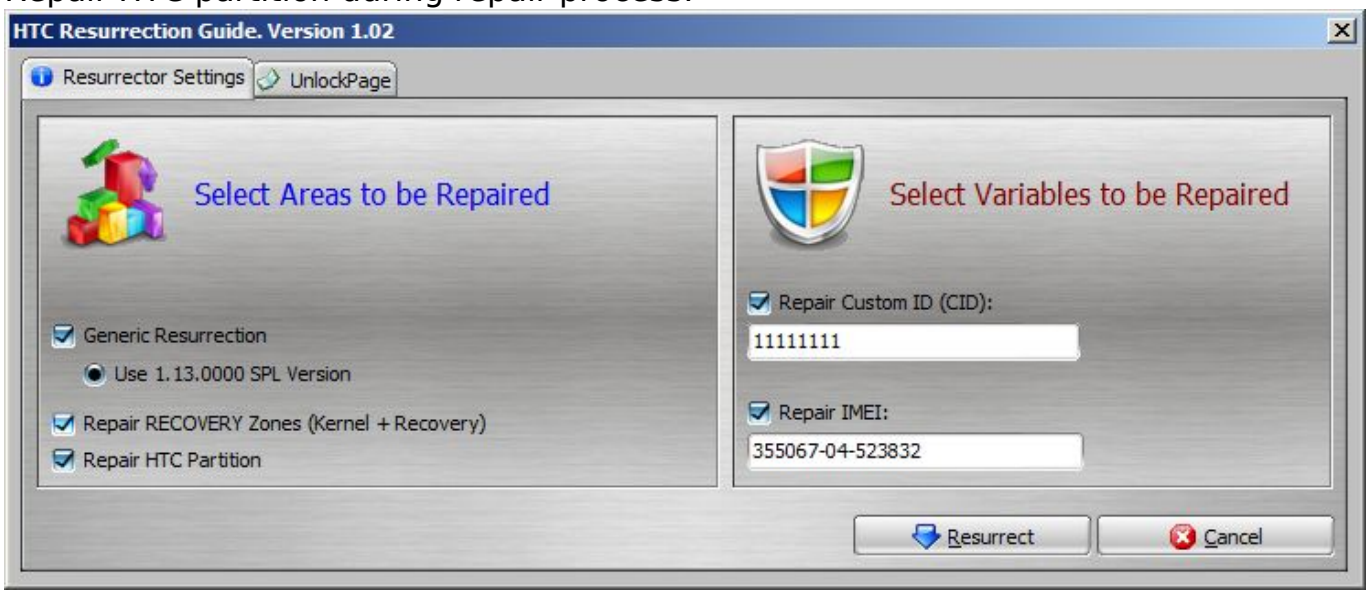
Returned by the DCC Loader when it was executing an extended command and that command failed. Extended command’s failure status is operation specific and is not relevant to communication problems.

Mostly happens with HTC phones when HTC partition is erased.

Repair HTC partition during repair process:
