RIFF JTAG Error codes and troubleshooting

Failed to receive answer to READ command.

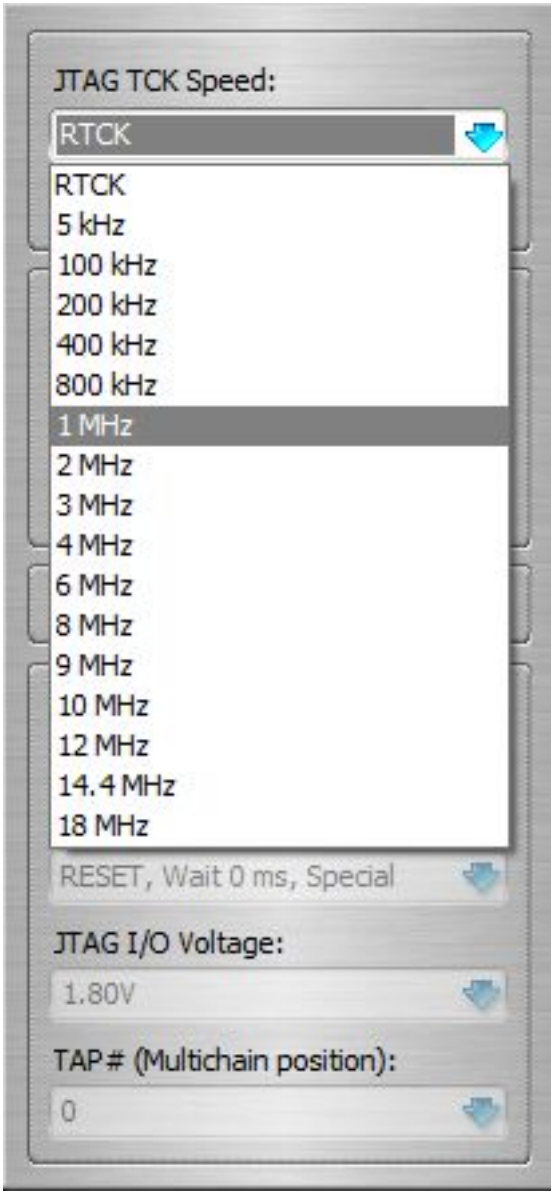
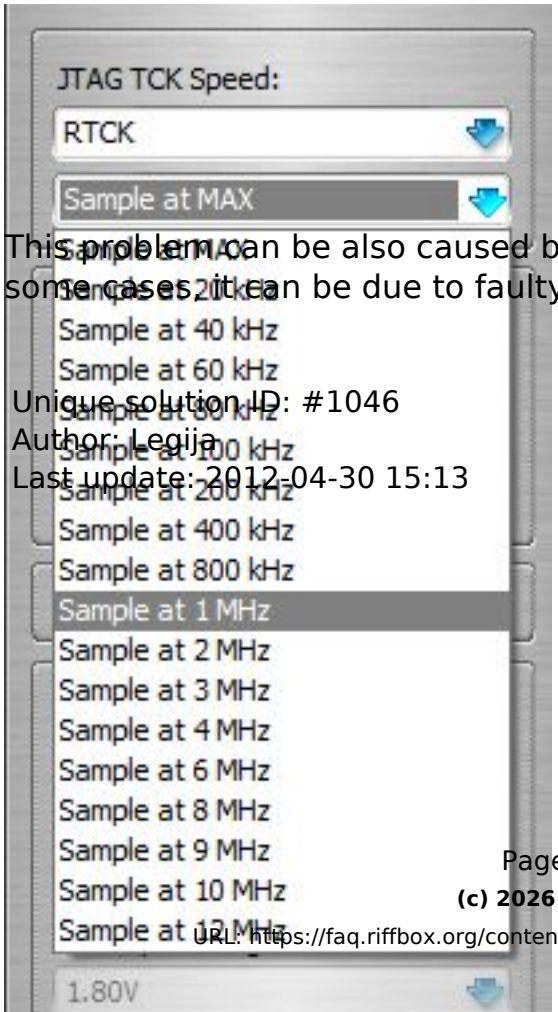
This problem can be also caused by bad connection, or bad 20pin ribbon cable. In some cases, it can be due to faulty target device hardware.

This error happens mostly due to high RTCK/TCK sampling rate. If You're using "Sample at Max" RTCK settings, set RTCK to lower value, for example to 1MHz. If You're using Fixed TCK, set it to lower value.
